## NOTIFICATION

#0001 Revision 2

SUBJECT: MGL OAT probe grounding.

MODELS AFFECTED: Sling LSA, Sling 2, Sling Taildragger and Sling 4 aircraft  
manufactured before the effective date (26/11/2015)

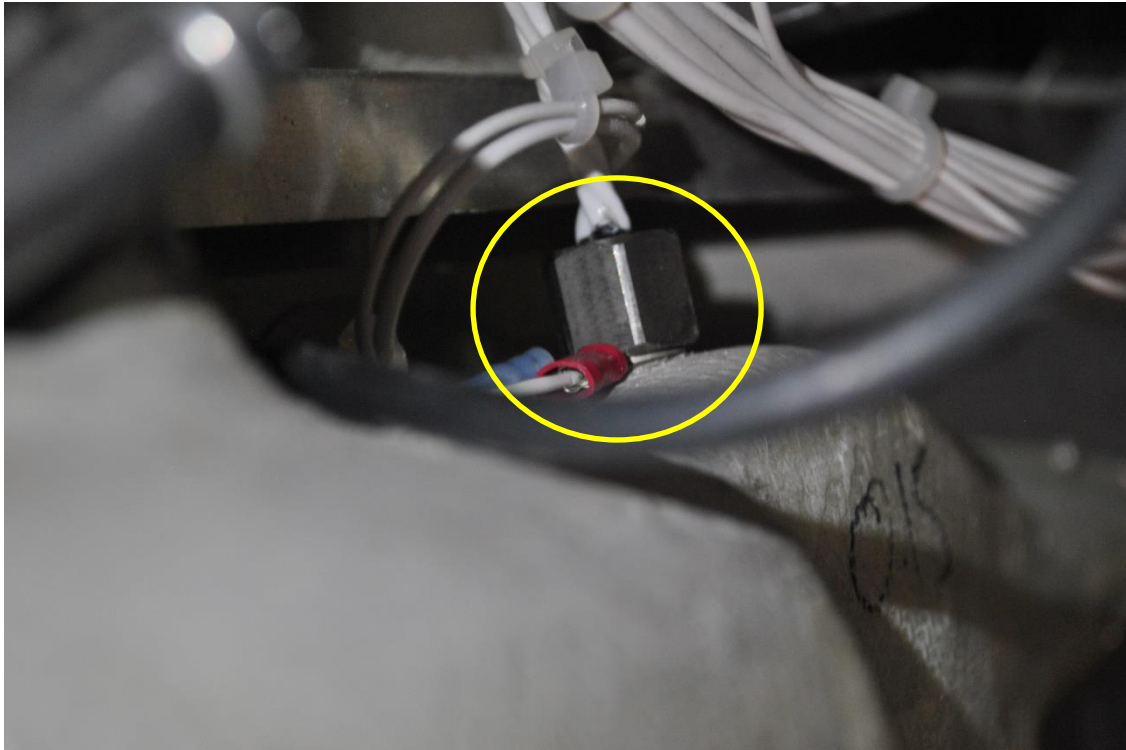
Figure 1: Grounding wire attached to the OAT probe

1. Visually inspect the outside air temperature probe from the inside of the cockpit. Verify whether the probe has been grounded or not.
2. If the OAT is grounded this Notification does not apply. Should the OAT probe not be grounded it is recommended that it be grounded
3. Using the grounding wire, visually measure the distance from the OAT probe to the ground bus of the aircraft.

4. Cut the wire so that it is the desired length to reach the ground bus.
5. Strip 5 mm of the insulation off of each side of the wire and crimp the ring terminals to each end.
6. Attach the 4 mm ring terminal to the ground bus.
7. Unscrew the OAT probe so as to slide the 10 mm terminal onto the probe.
8. Tighten the OAT probe to ensure a tight fit.
9. Notification of this service bulletin needs to be sent to the Airplane Factory (Pty) Ltd. Please make use of the following contact details: [Airworthiness@airplanefactory.co.za](mailto:Airworthiness@airplanefactory.co.za)
