## **SERVICE BULLETIN**

#0024 Revision 2

**SUBJECT:** Throttle cable replacement to prevent potential loss of engine power control.

**MODELS AFFECTED:** All Rotax 912 iS and 915 iS fitted Sling aircraft manufactured before the effective date (01/06/2023).

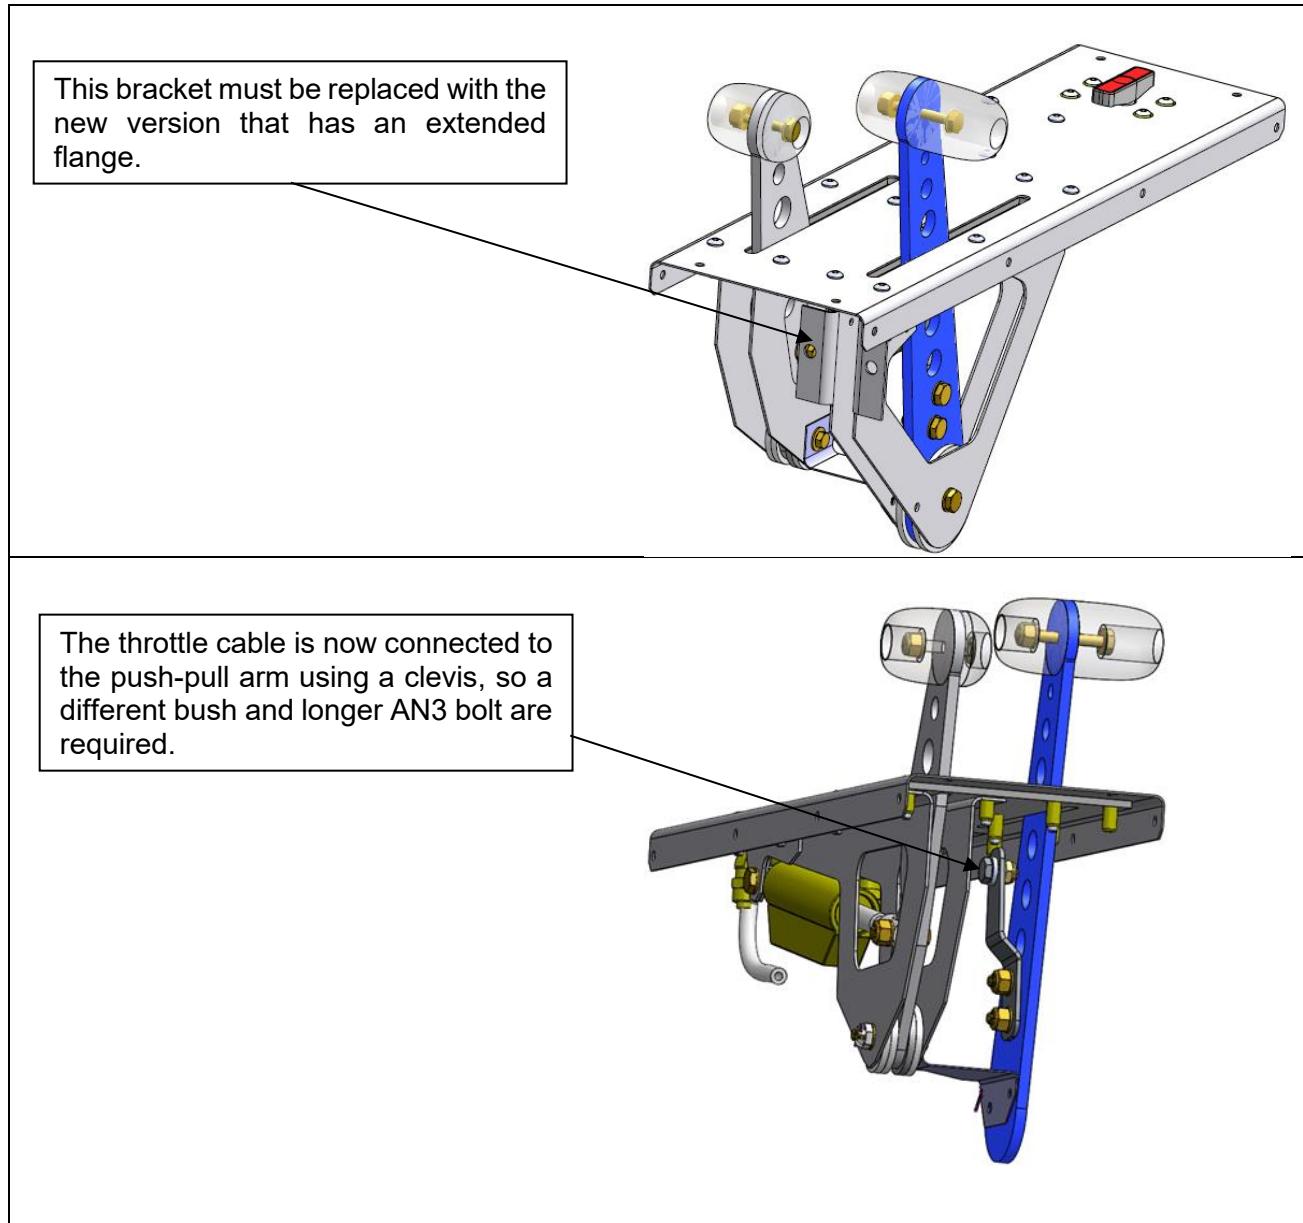
The new throttle cable assembly makes use of a clevis and modified clevis sheath housing. Due to this, certain of the brackets in the throttle quadrant assembly need to be changed to the new versions. The figures below detail the required changes for the respective aircraft. Figure 1 details the components that need to change on Sling 2, Sling LSA and Sling 4 TSi, whereas Figure 2 details the changes for the Sling 4 High Wing.

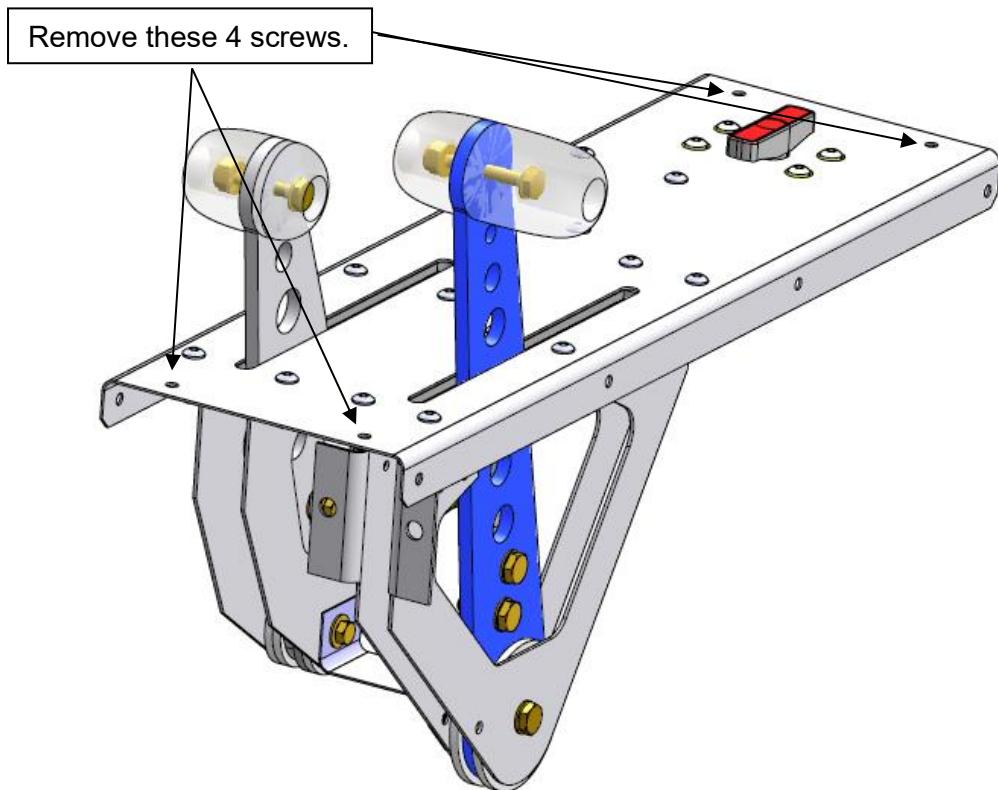
Figure 3

Step 3: Once the side inspection panel has been removed, remove the 4 screws that hold the throttle quadrant in place, refer to Figure 3. This is to allow the throttle quadrant to be lifted and tilted for better access to the components beneath. Be careful not to pull the brake line off when you lift the throttle quadrant. The brake line should be long enough to remain attached during the entire replacement process.

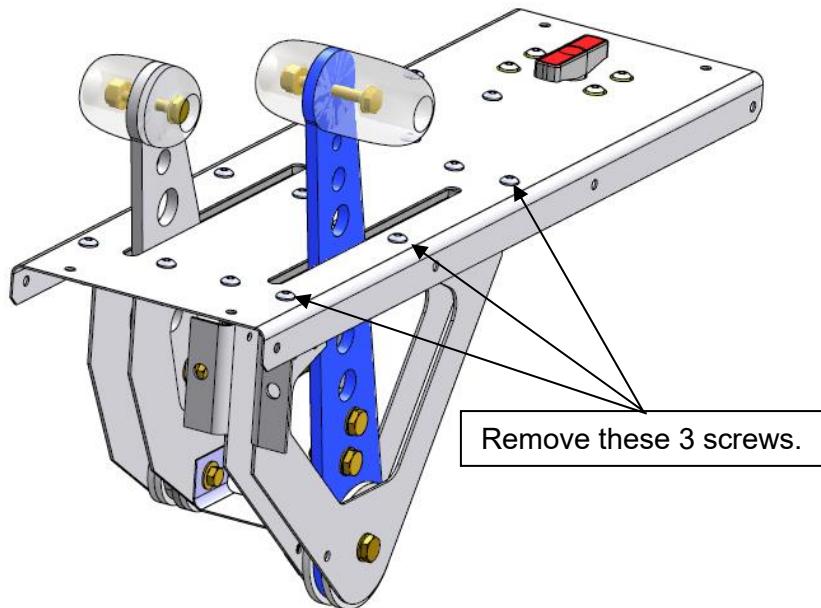
Figure 4

Step 4: Remove the 3 screws attaching the outer bracket to the top mount plate of the throttle quadrant. Refer to Figure 4.

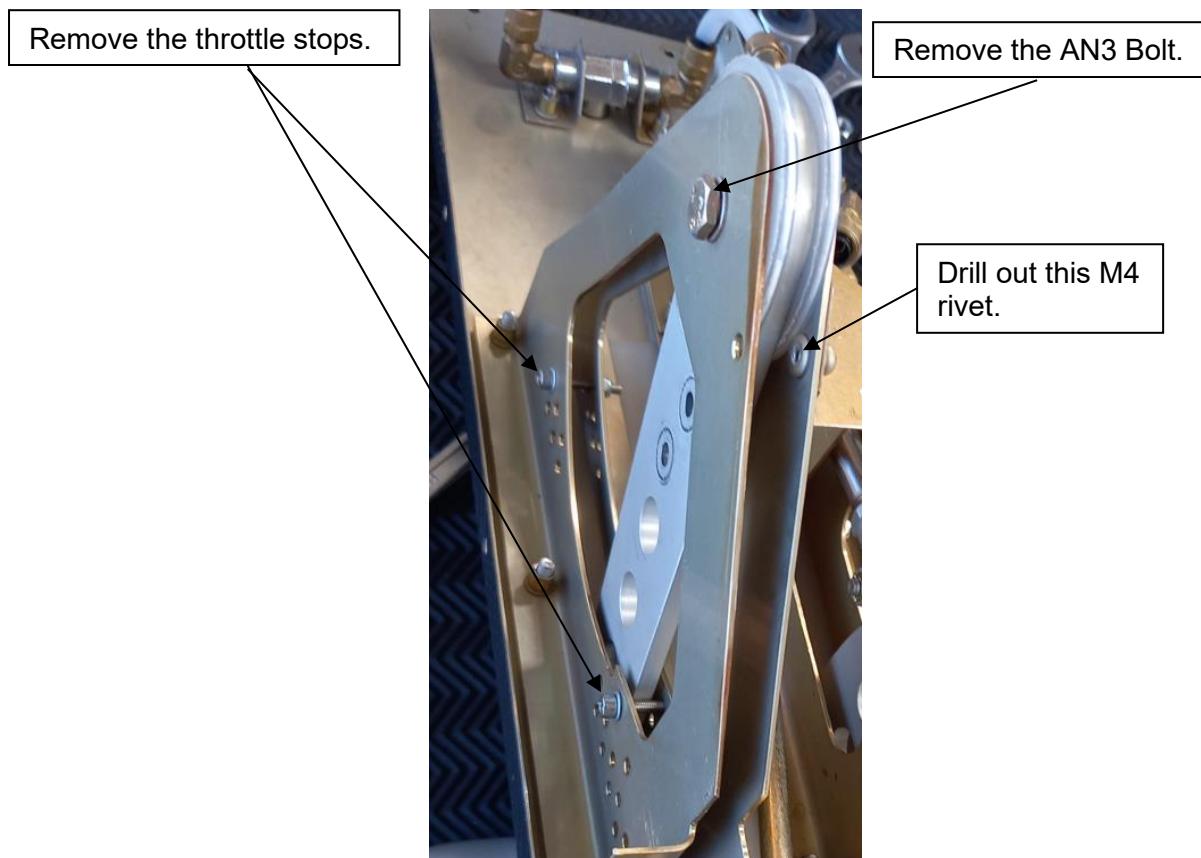
Figure 5

Step 5: Once the three screws have been removed from the outer bracket, remove the AN3 bolt shown in Figure 5, as well as the throttle stops. After the bolts have been uninstalled, the bracket can be removed, and the rivet must be drilled out.

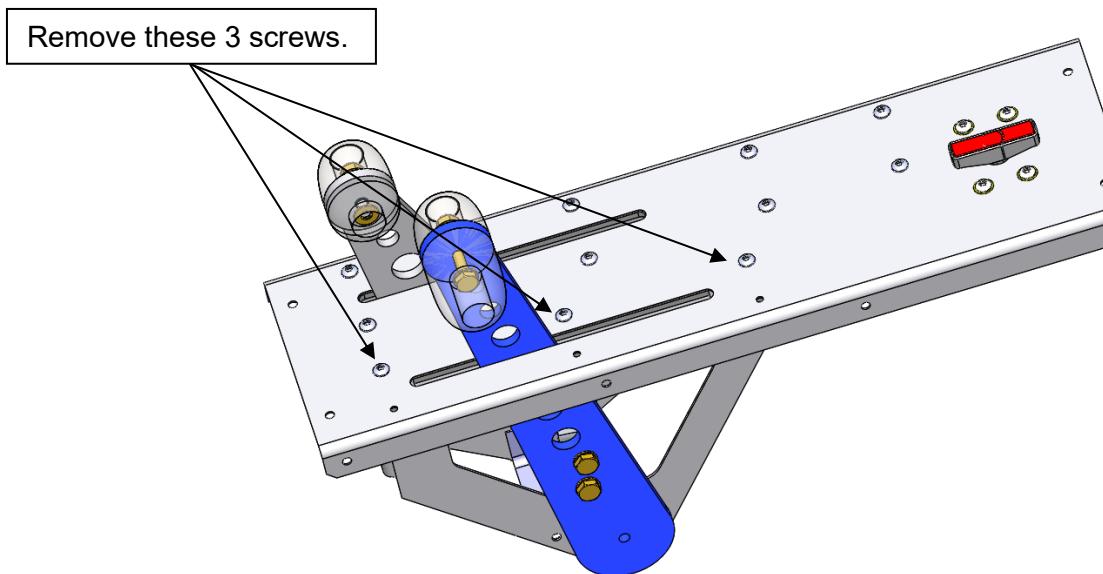
Figure 6

Step 6: Remove the 3 screws retaining the remaining bracket as seen in Figure 6.

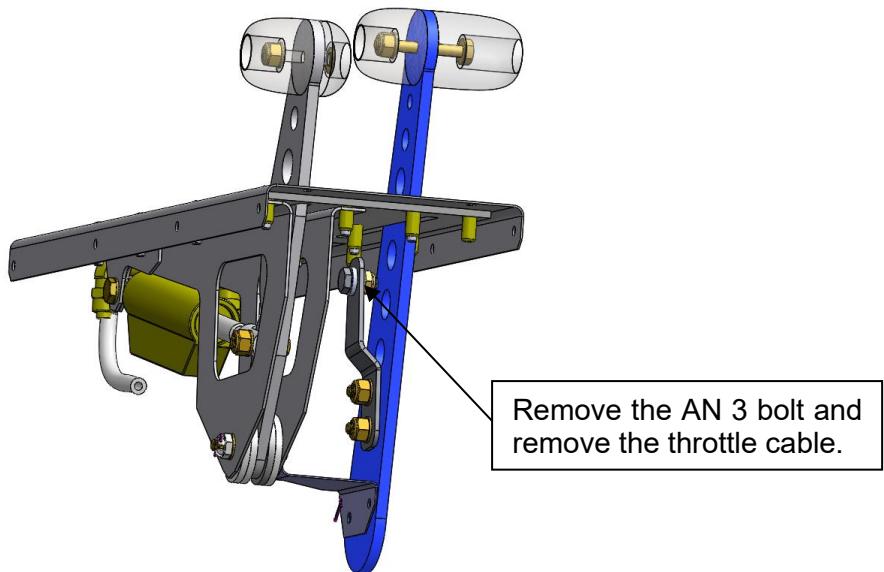
Figure 7

Step 7: Remove the AN 3 bolt attaching the throttle cable to the push-pull arm. A new bolt and bush will need to be installed in order to attach the new throttle cable. This will be detailed in Section 3.3.

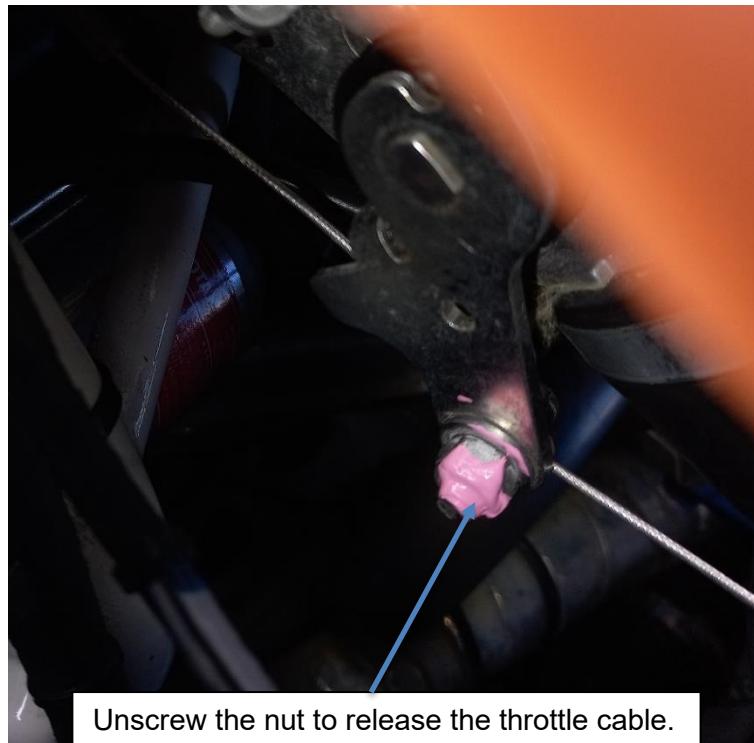
Figure 8

Step 9: Unscrew the nut on the throttle lever on the Rotax throttle body to release the throttle cable. Refer to Figure 8.

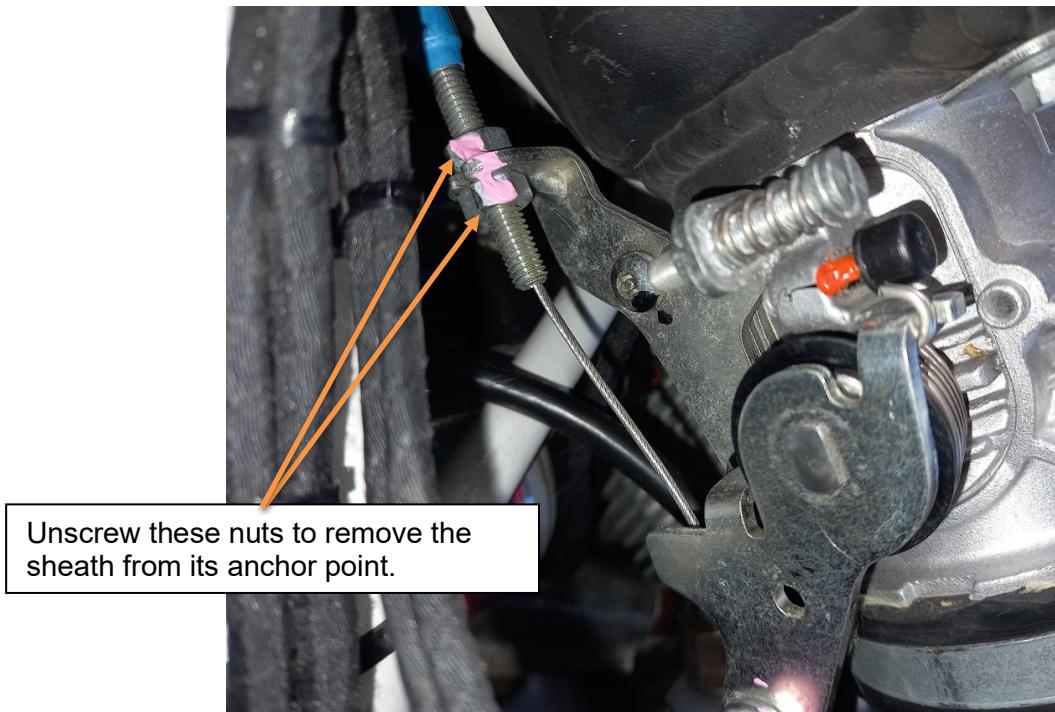
Step 10: In order to remove the throttle cable and sheath, it needs to be detached from the engine. To do so, unscrew the locking nuts that hold the sheath in place. Refer to Figure 9

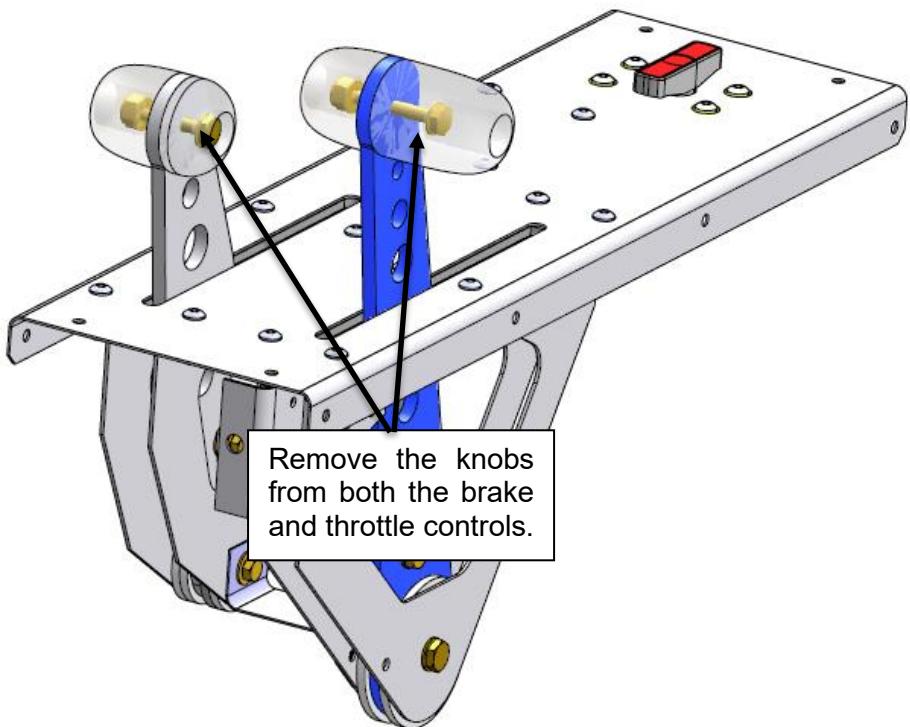
Figure 10

Step 3: Once the left side inspection panel has been removed, remove the AN 3 bolts from the control handles so that the handle knobs can be removed. This must be done for both the brake and throttle handles.

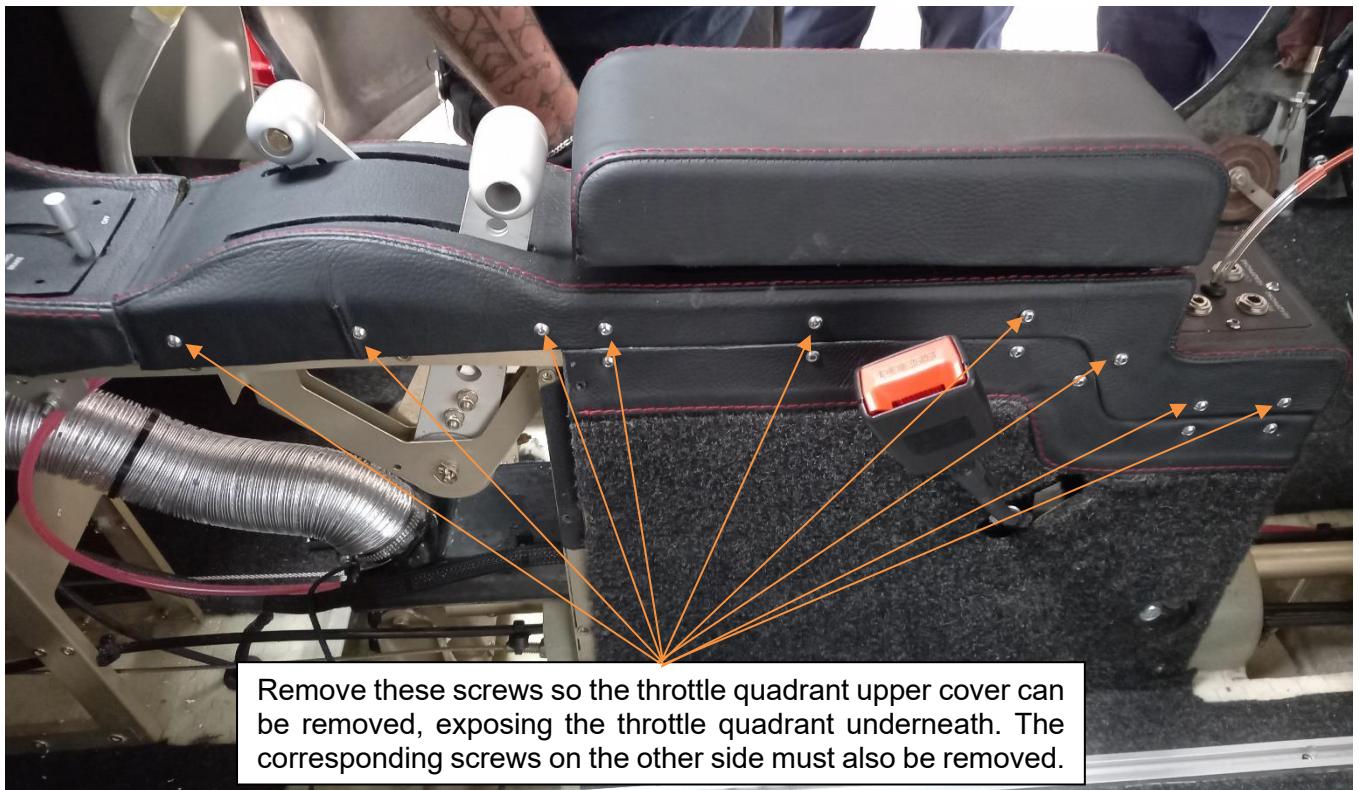
Figure 11

Step 4: After the control handle knobs have been removed, remove the screws of the throttle quadrant upper cover. This cover must then be lifted off to expose the throttle quadrant underneath.

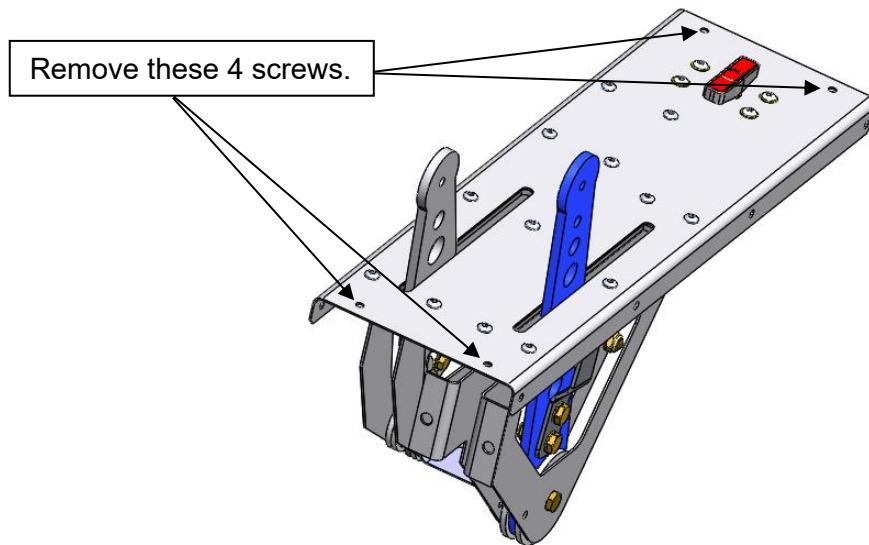
Figure 12

Step 5: Once the side inspection panel has been removed, remove the 4 screws that hold the throttle quadrant in place, refer to Figure 12. This is to allow the throttle quadrant to be lifted and tilted for better access to the components beneath. Be careful not to pull the brake line off when you lift the throttle quadrant. The brake line should be long enough to remain attached during the entire throttle cable replacement process.

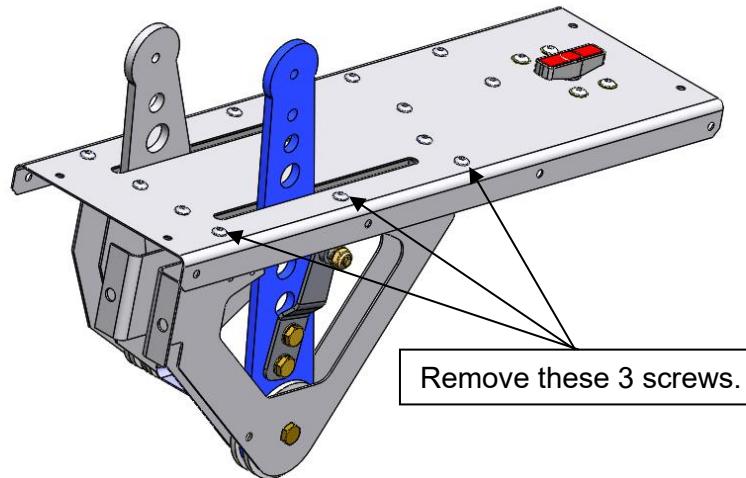
Figure 13

Step 6: Remove the 3 screws attaching the outer bracket to the top mount plate of the throttle quadrant. Refer to Figure 13.

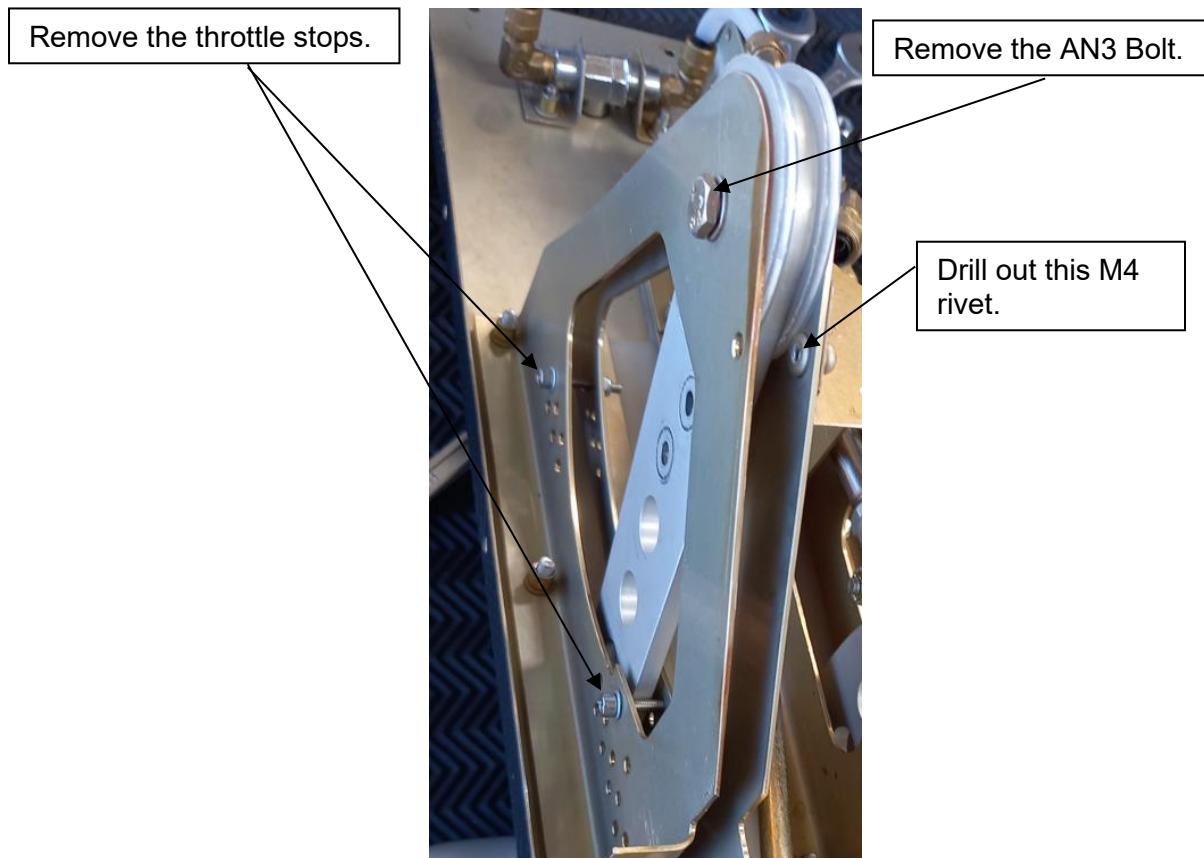
Figure 14

Step 7: Once the three screws have been removed from the outer bracket, remove the AN3 bolt shown in Figure 14, as well as the throttle stops. Once the bolts have been uninstalled, the bracket can be removed, and the rivet must be drilled out.

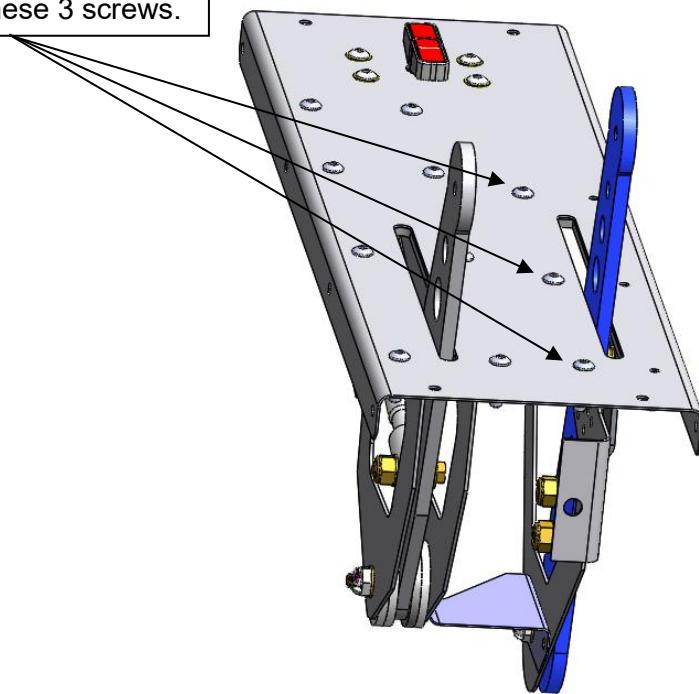
Figure 15

Step 8: Remove the 3 screws retaining the remaining bracket as seen in Figure 15.

Remove these 3 screws.

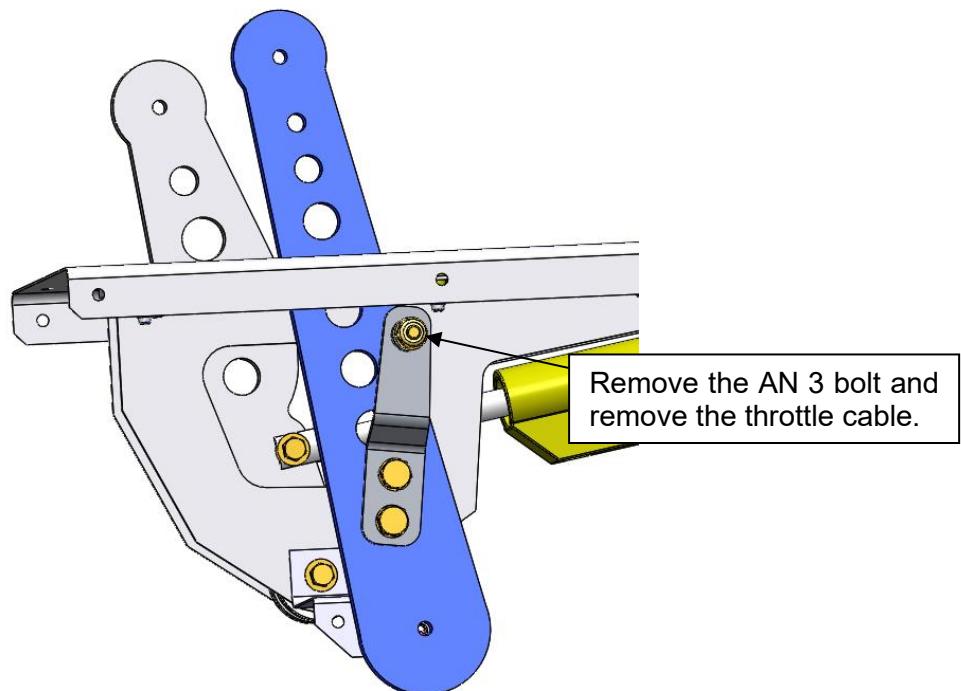
Figure 16

Step 9: Remove the AN 3 bolt attaching the throttle cable to the push-pull arm. A new bolt and bush will need to be installed in order to attach the new throttle cable, this will be detailed in Section 3.2.

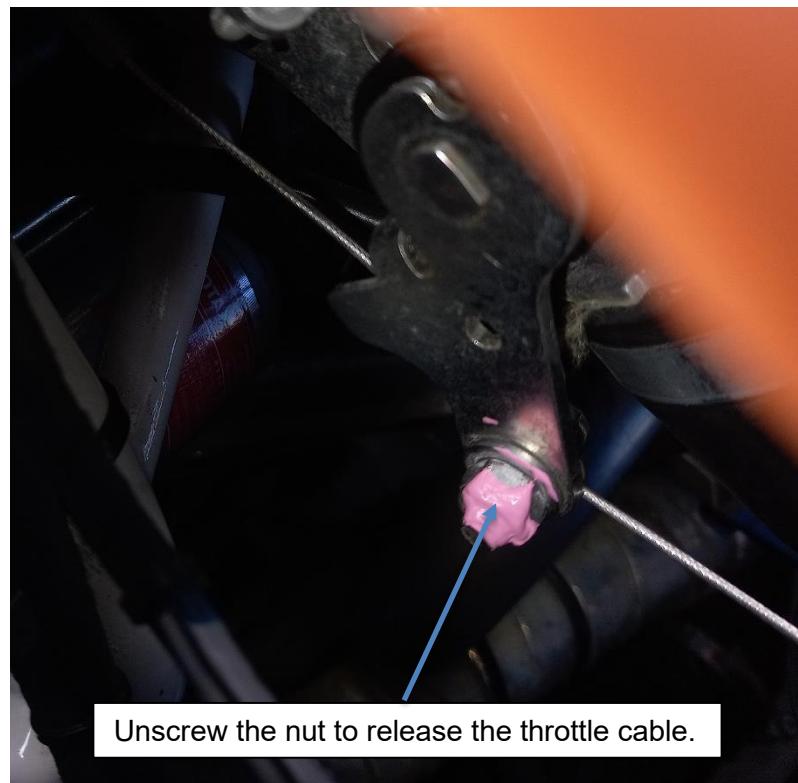
Figure 17

Step 11: Unscrew the nut on the throttle lever on the Rotax throttle body to release the throttle cable. Refer to Figure 17.

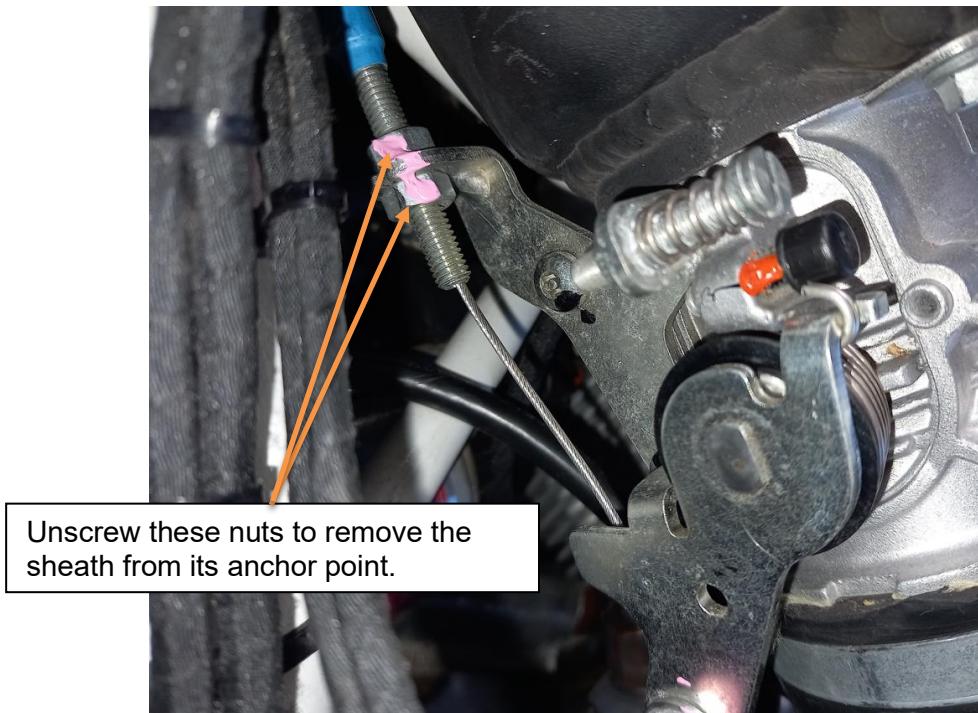
Figure 18

Step 12: In order to remove the throttle cable and sheath, it needs to be detached from the engine. To do so, unscrew the locking nuts that hold the sheath in place. Refer to Figure 18.

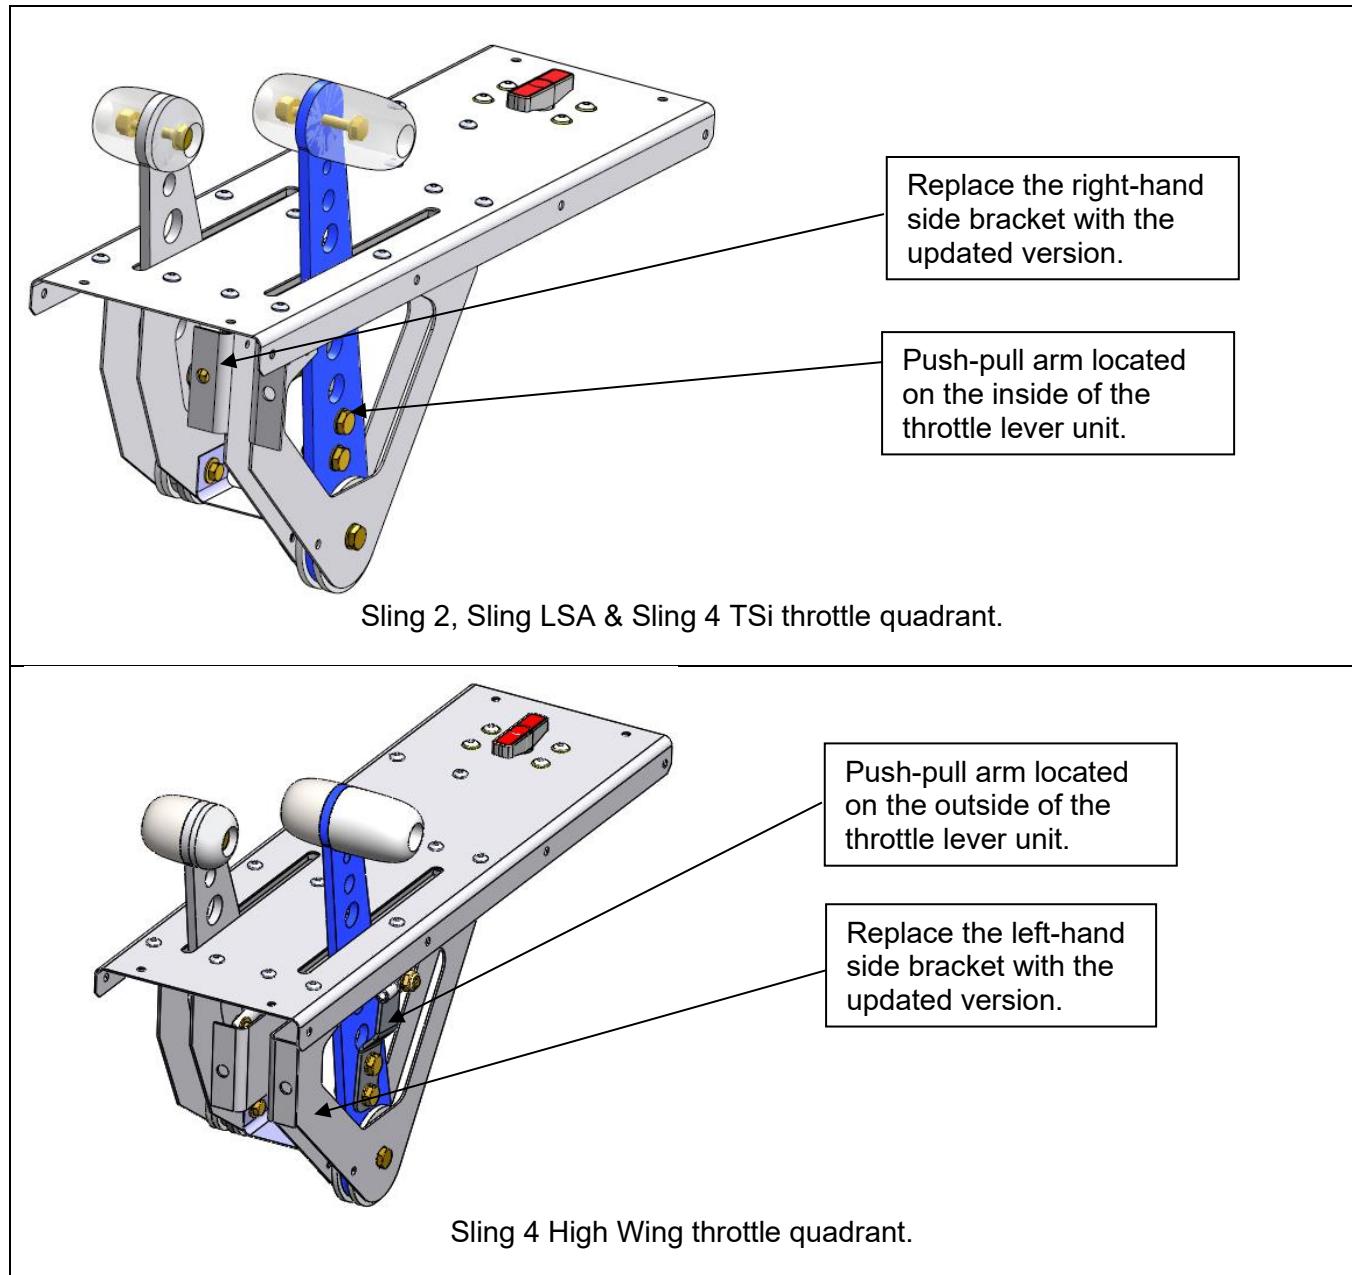
Figure 19

As depicted in Figure 19, the only difference between the throttle quadrant of the Sling 4 High Wing and the other aircraft is the side of the throttle lever that the push-pull arm is mounted to. The section below details the replacement of the throttle cable in order for the Sling 2, Sling LSA and Sling 4 TSi. In order to replace the components on the Sling 4 High Wing just mirror the process for the opposite bracket depicted below in Figure 19.

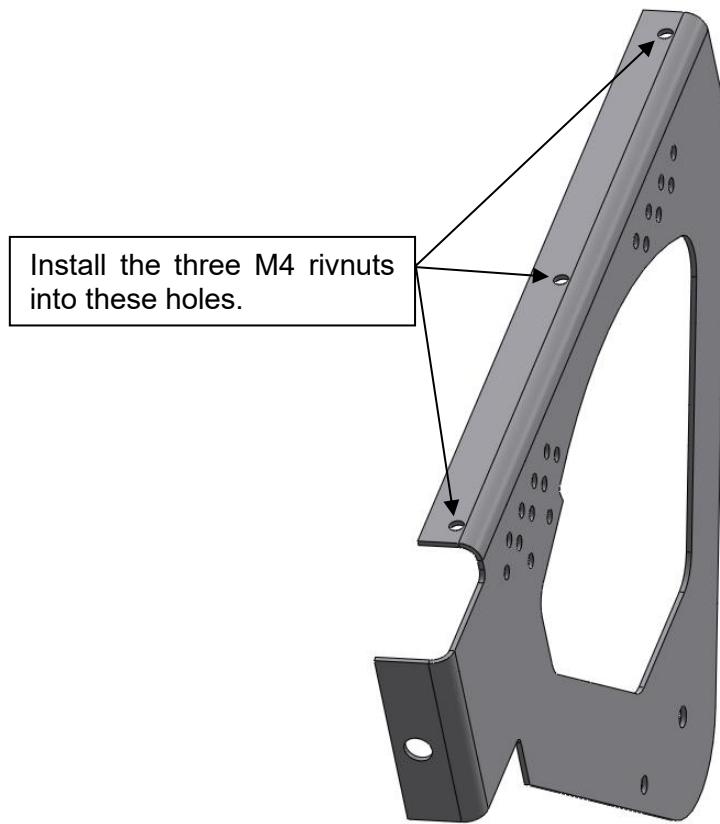
Step 1: Install M4 rivnuts onto the new throttle cable bracket (CT-BKT-038-R-X-0). Refer to Figure 20 for the location of where to install the rivnuts.

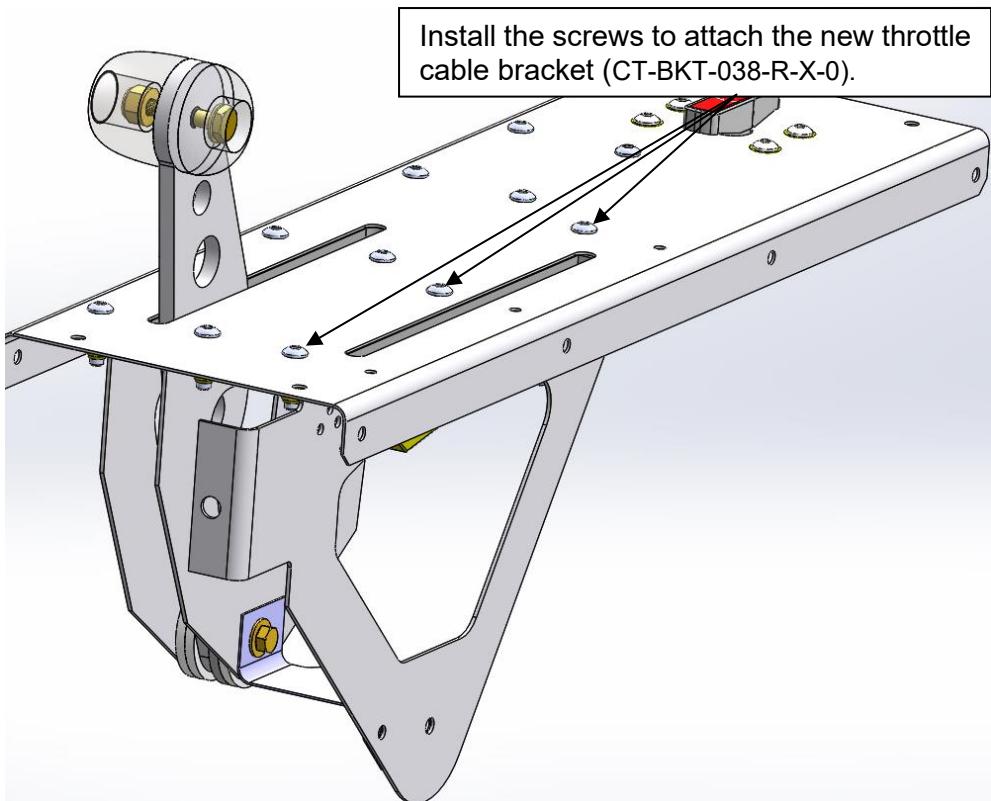
Figure 21

Step 2: Install the screws so that the new bracket is attached to the throttle quadrant upper plate, as see in Figure 21.

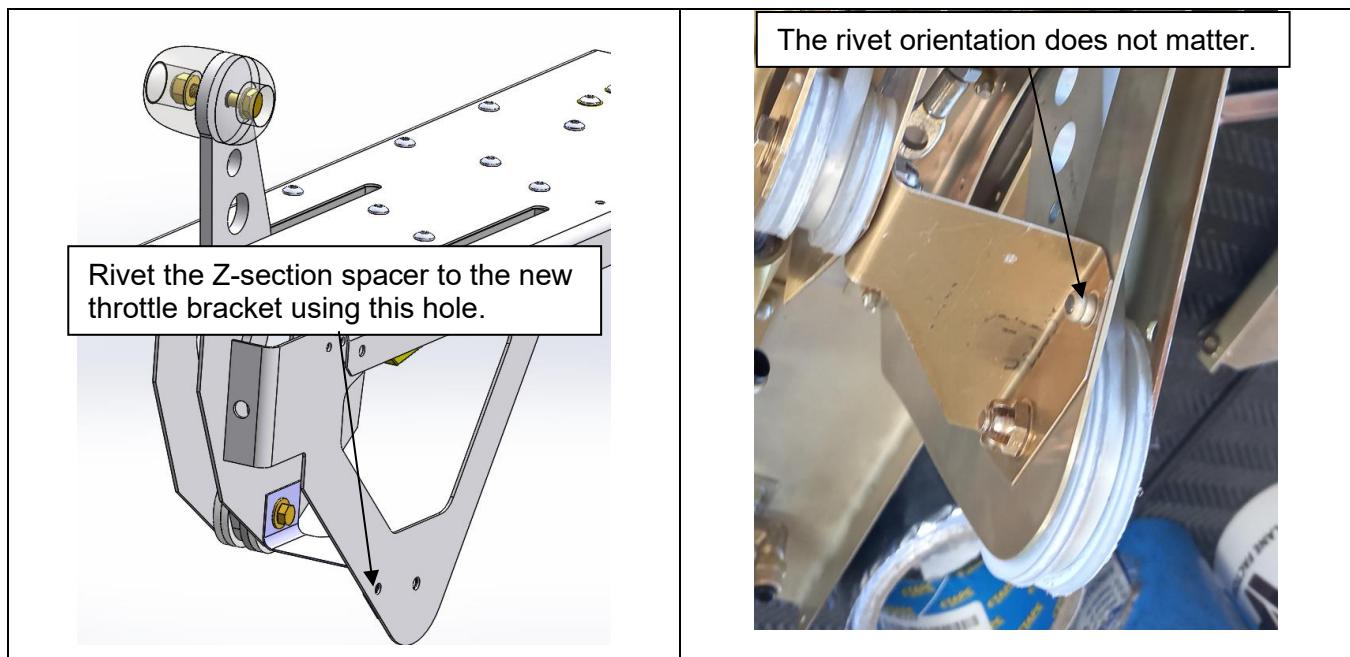
Figure 22

Step 3: Rivet the new bracket to the throttle quadrant Z-Section Spacer as seen in Figure 22, using the M4x10 rivet.

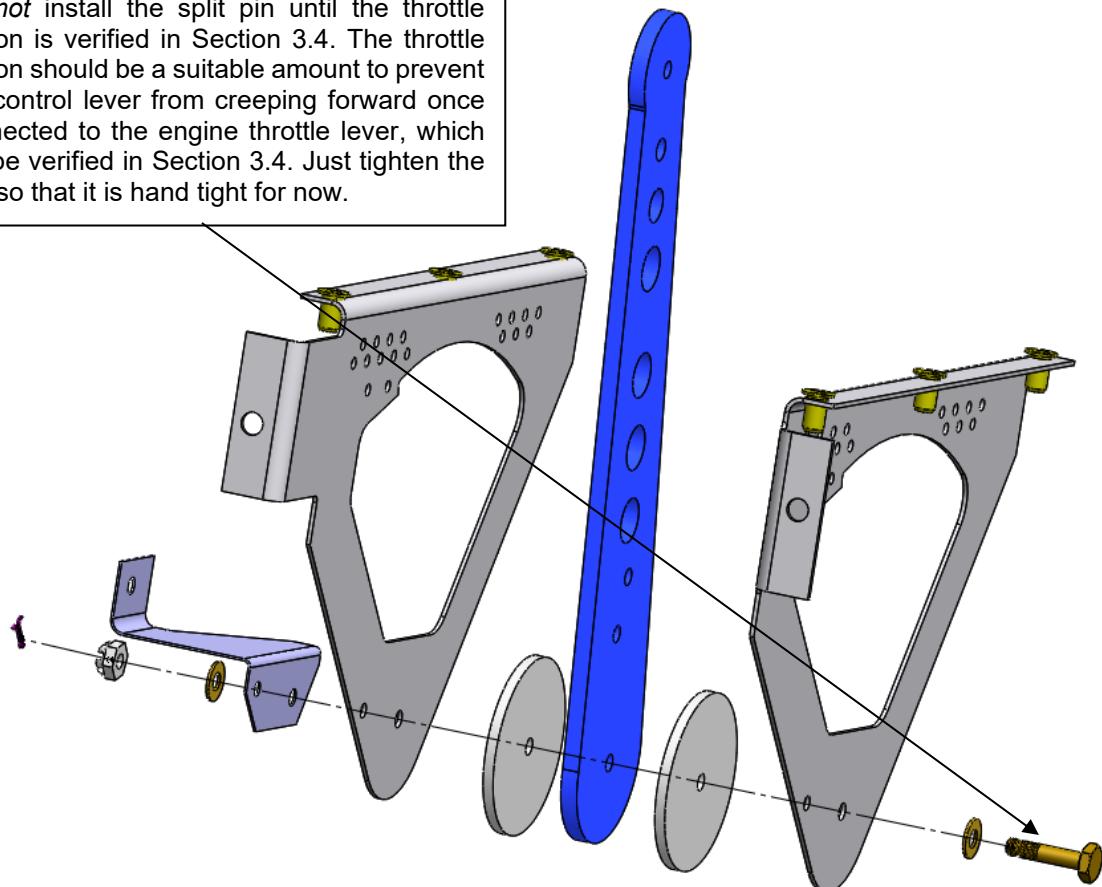
Step 4: Reinstall the throttle lever assembly and outer bracket, refer to Figure 23 for how the components go back together.

*Do not install the split pin until the throttle friction is verified in Section 3.4. The throttle friction should be a suitable amount to prevent the control lever from creeping forward once connected to the engine throttle lever, which will be verified in Section 3.4. Just tighten the bolt so that it is hand tight for now.*

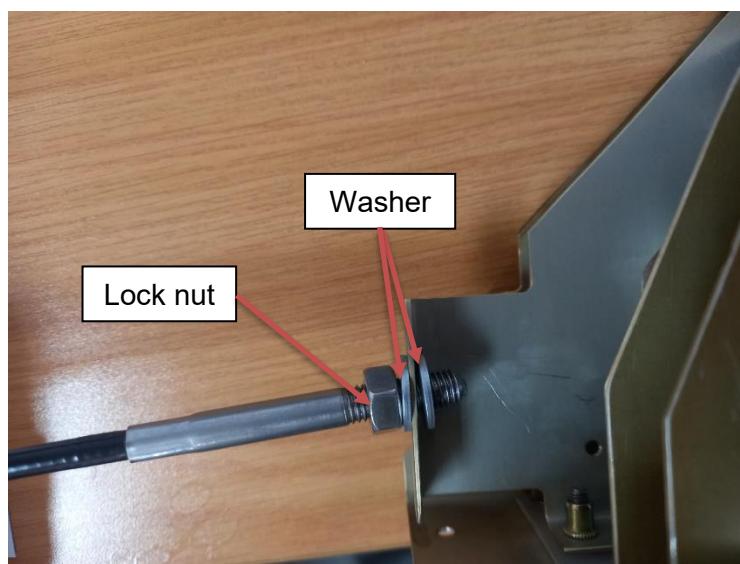
Figure 24

Step 5: Connect the sheaths threaded section to the right hand Throttle Quadrant Plate. Refer to Figure 24.

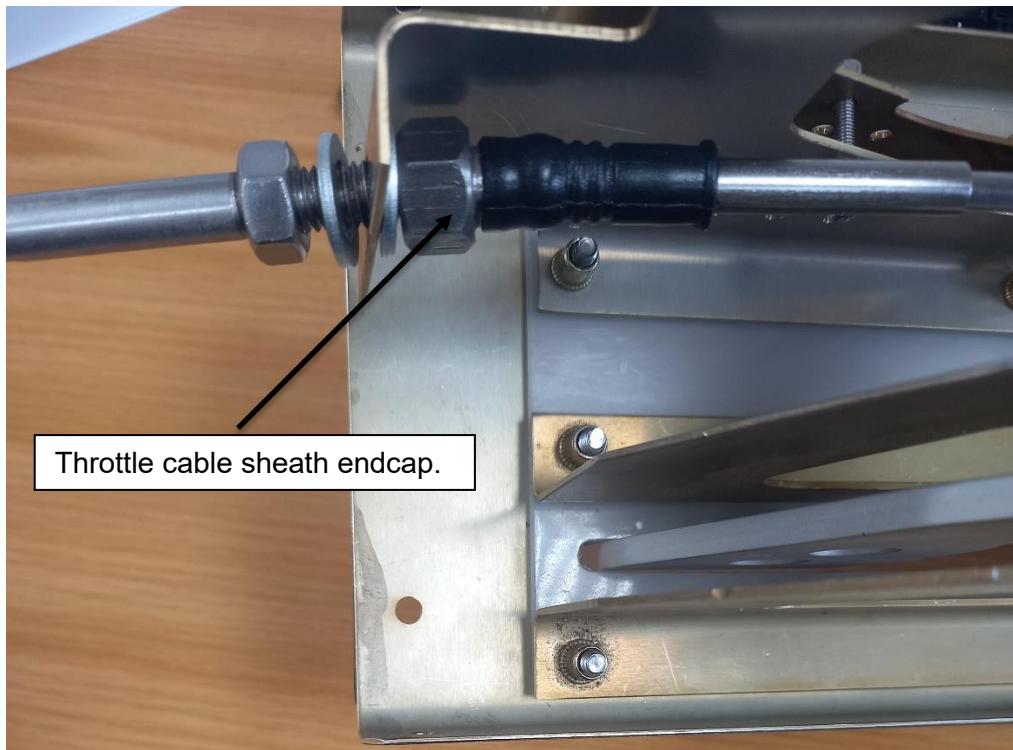
Figure 25

Step 6: Screw on the sheath endcap. Ensure that the play in the joint does not decrease once the end cap is screwed onto the sheath. If the joint has stiffened up, unscrew the nut by 1 rotation to allow sufficient play in the joint. Refer to Figure 25.

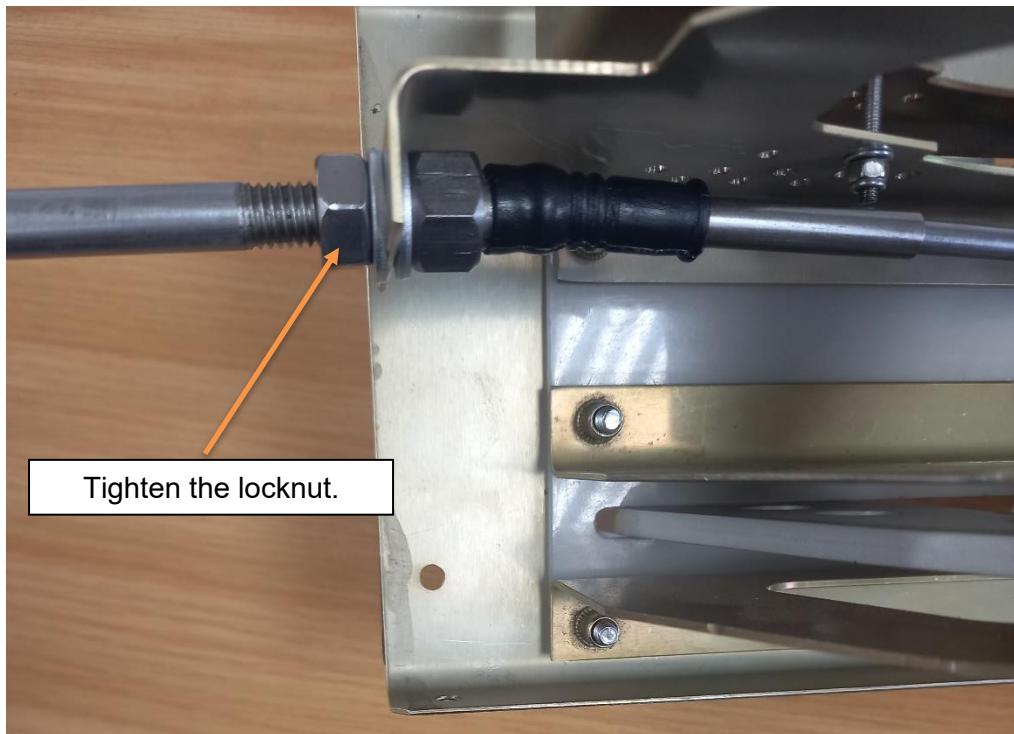
Figure 26

Step 7: Once the throttle cable sheath endcap has been screwed on, tighten the lock-nut so that the sheath is locked in place. If there is still sufficient play in the joint, apply torque seal to the locknuts.

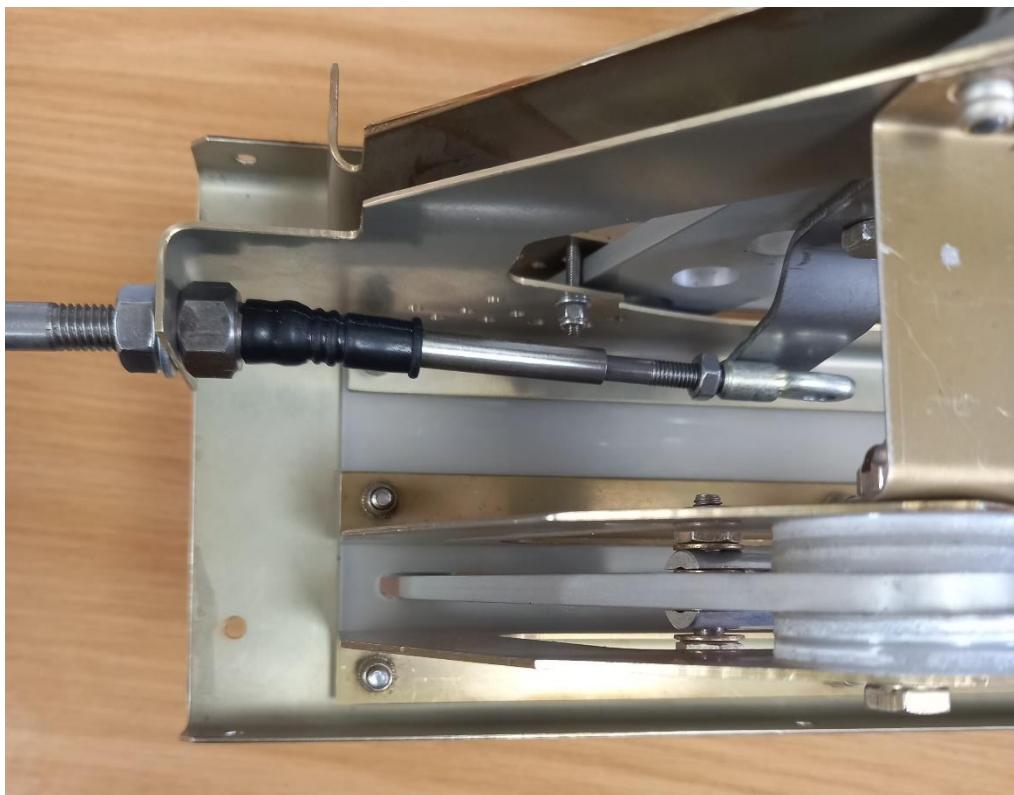
Step 8: Thread the throttle cable through the sheath so that the clevis is inserted into the throttle endcap. Refer to Figure 27 for what the clevis looks like once the throttle cable has been inserted into the throttle cable sheath.

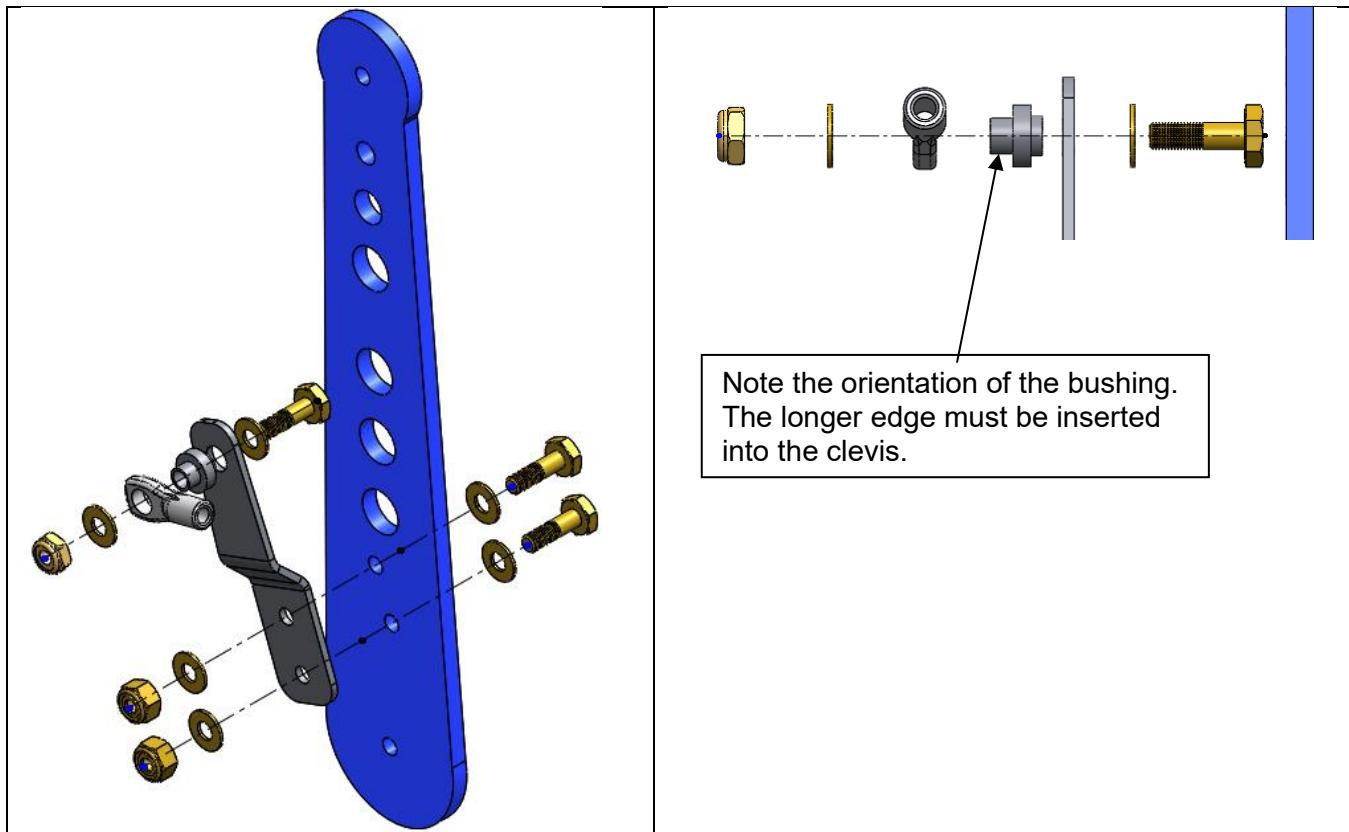
Step 9: Refer to Figure 28 for how the clevis gets connected to the throttle lever arm.
