## **SERVICE BULLETIN**

#0024 Revision 2

**SUBJECT:** Throttle cable replacement to prevent potential loss of engine power control.

**MODELS AFFECTED:** All Rotax 912 iS and 915 iS fitted Sling aircraft manufactured before the effective date (01/06/2023).

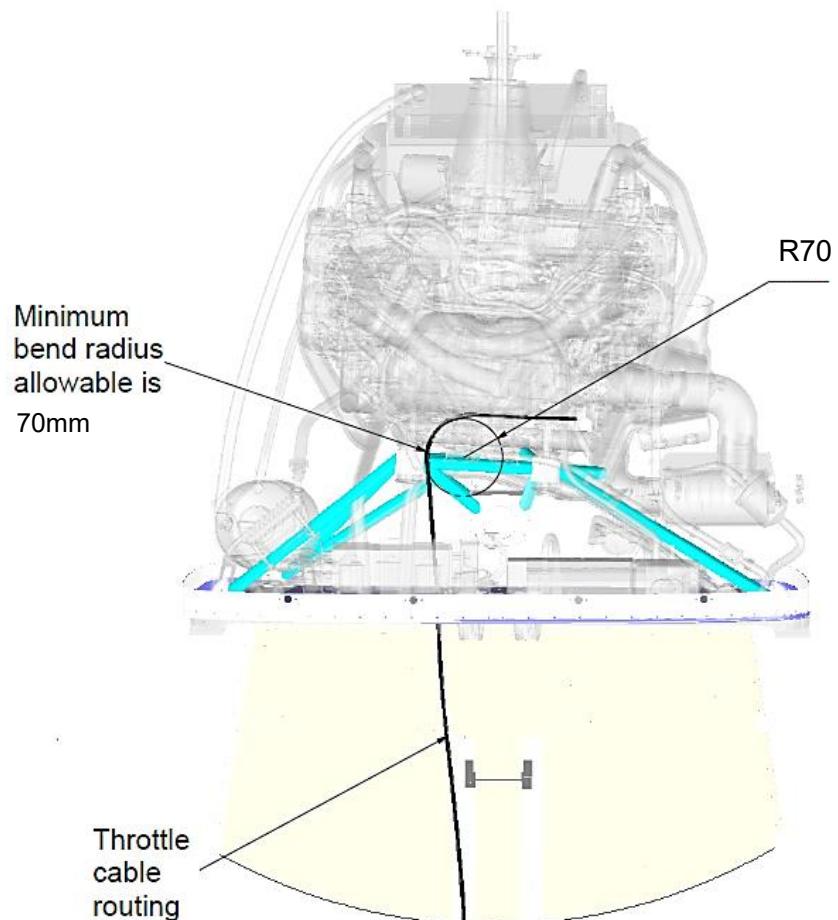
Figure 29

Step 10: Route the throttle cable and its sheath through the firewall, to the throttle lever on the Rotax throttle body. The cable should not have a bend radius smaller than 70 mm. If the bend is too tight there will be increased friction in the system. Ensure that there are no kinks in the cable from the throttle quadrant to the firewall. Standoffs may be used as necessary.

### THROTTLE CABLE ROUTING

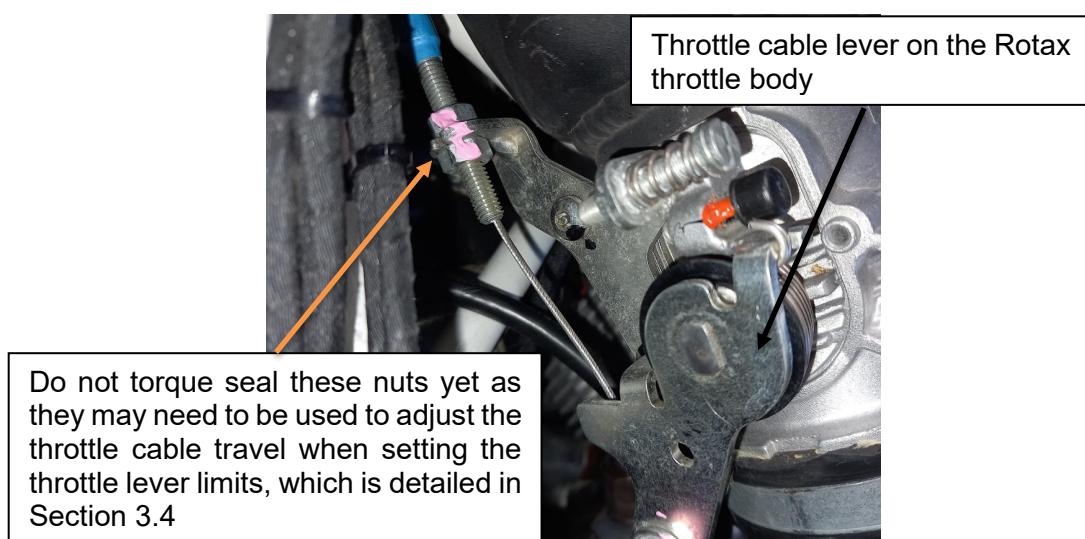
Figure 30

Step 11: Connect the throttle cable sheath to the mounting point on the throttle body.

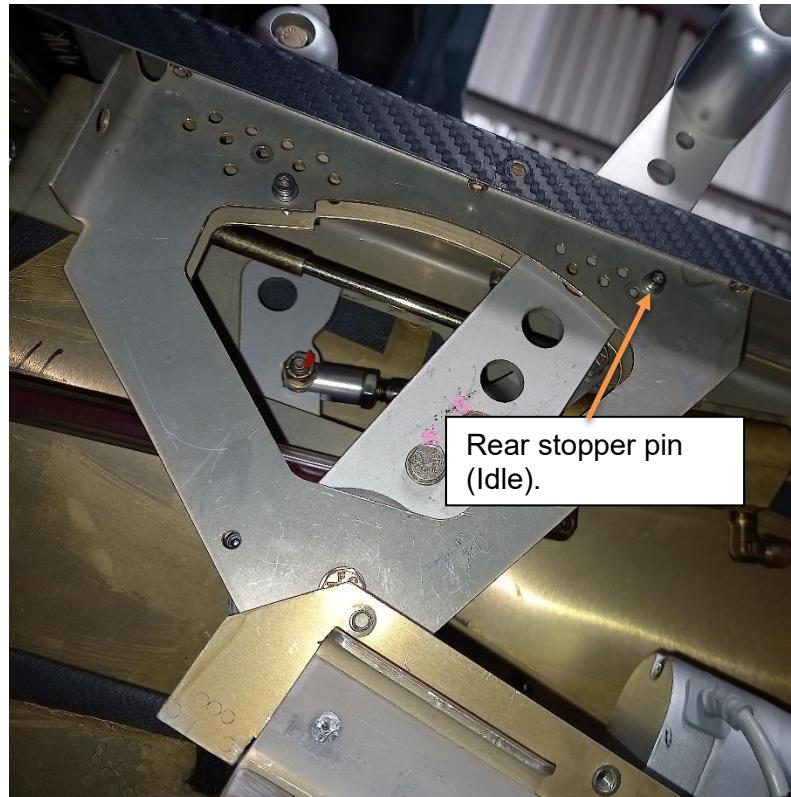
Step 1: Install rear stopper pins to set the idle position of the throttle lever. The idle position stopper pin should be installed so that the throttle lever can be pulled as far back as possible without contacting the throttle quadrant upper plate. Figure 31 shows an example of the idle positions determined for an aircraft. Note: The idle position of the stopper pin may differ slightly from aircraft to aircraft.

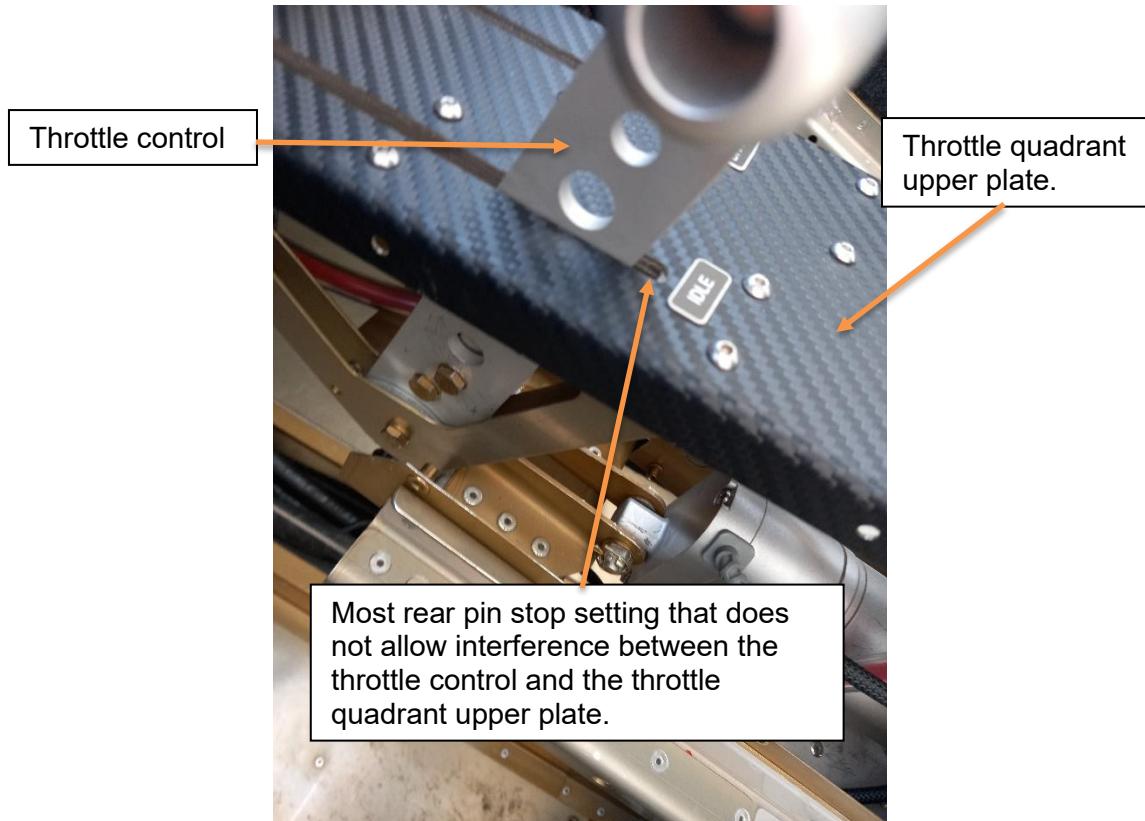
Figure 32

- Step 2: With the throttle control set to idle as seen above, connect the throttle cable to the throttle lever on the Rotax throttle body, while the throttle lever is in the idle position. Tighten the locking nut to fix the cable to the throttle lever and apply torque seal.
- Step 3: Push the throttle control forward until the throttle lever on the Rotax throttle body is fully open. Put the front stopper into the nearest hole so that it stops the control in the fully open position.
- Step 4: Once the stopper pins are set, check that the throttle lever goes to fully open and idle respectively. The throttle cable travel can be adjusted slightly by adjusting the locknuts on the sheath holding the sheath to the Rotax throttle body. Refer to Figure 33.

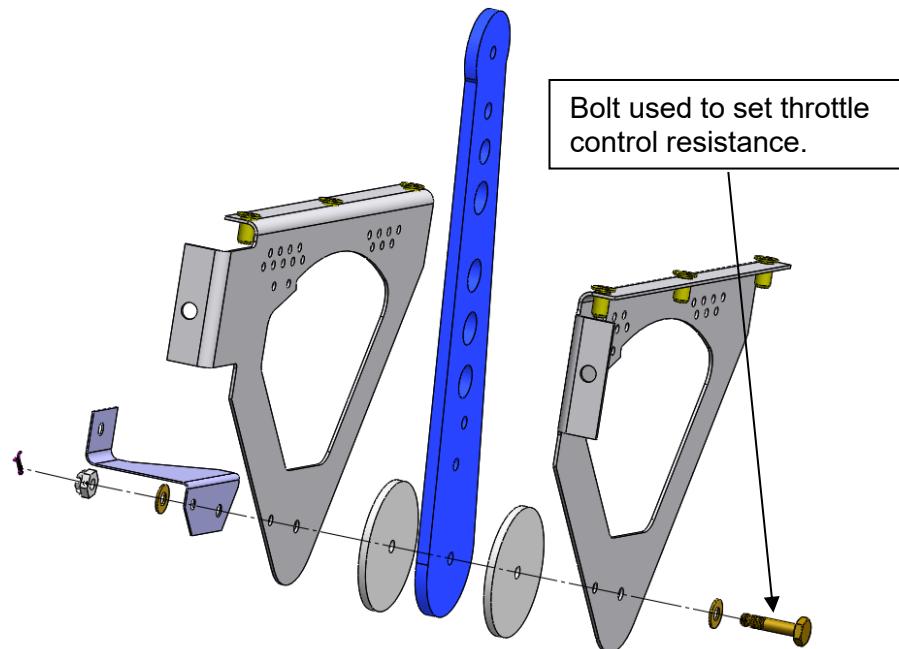
Figure 34

Step 6: Pull the throttle to idle and confirm that the throttle control is smooth, has a suitable feel and that the lever does not creep forward under the tension of the spring on the engine side. If the control creeps forward tighten the bolt referred to in Figure 34. Once the friction is suitable to avoid the control from creeping forward, insert the split pin as seen in Figure 34.

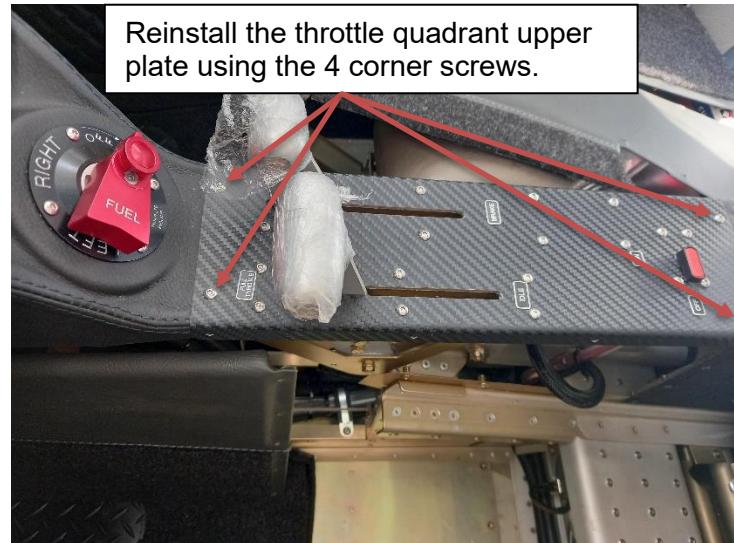
Figure 35

Step 7: Reinstall the 4 corner screws to reattach the throttle quadrant upper plate to the throttle centre console.
