SERVICE BULLETIN

#0024

SUBJECT: Throttle cable replacement to prevent potential loss of engine power control.

MODELS AFFECTED: All Rotax 912 iS and 915 iS fitted Sling aircraft.

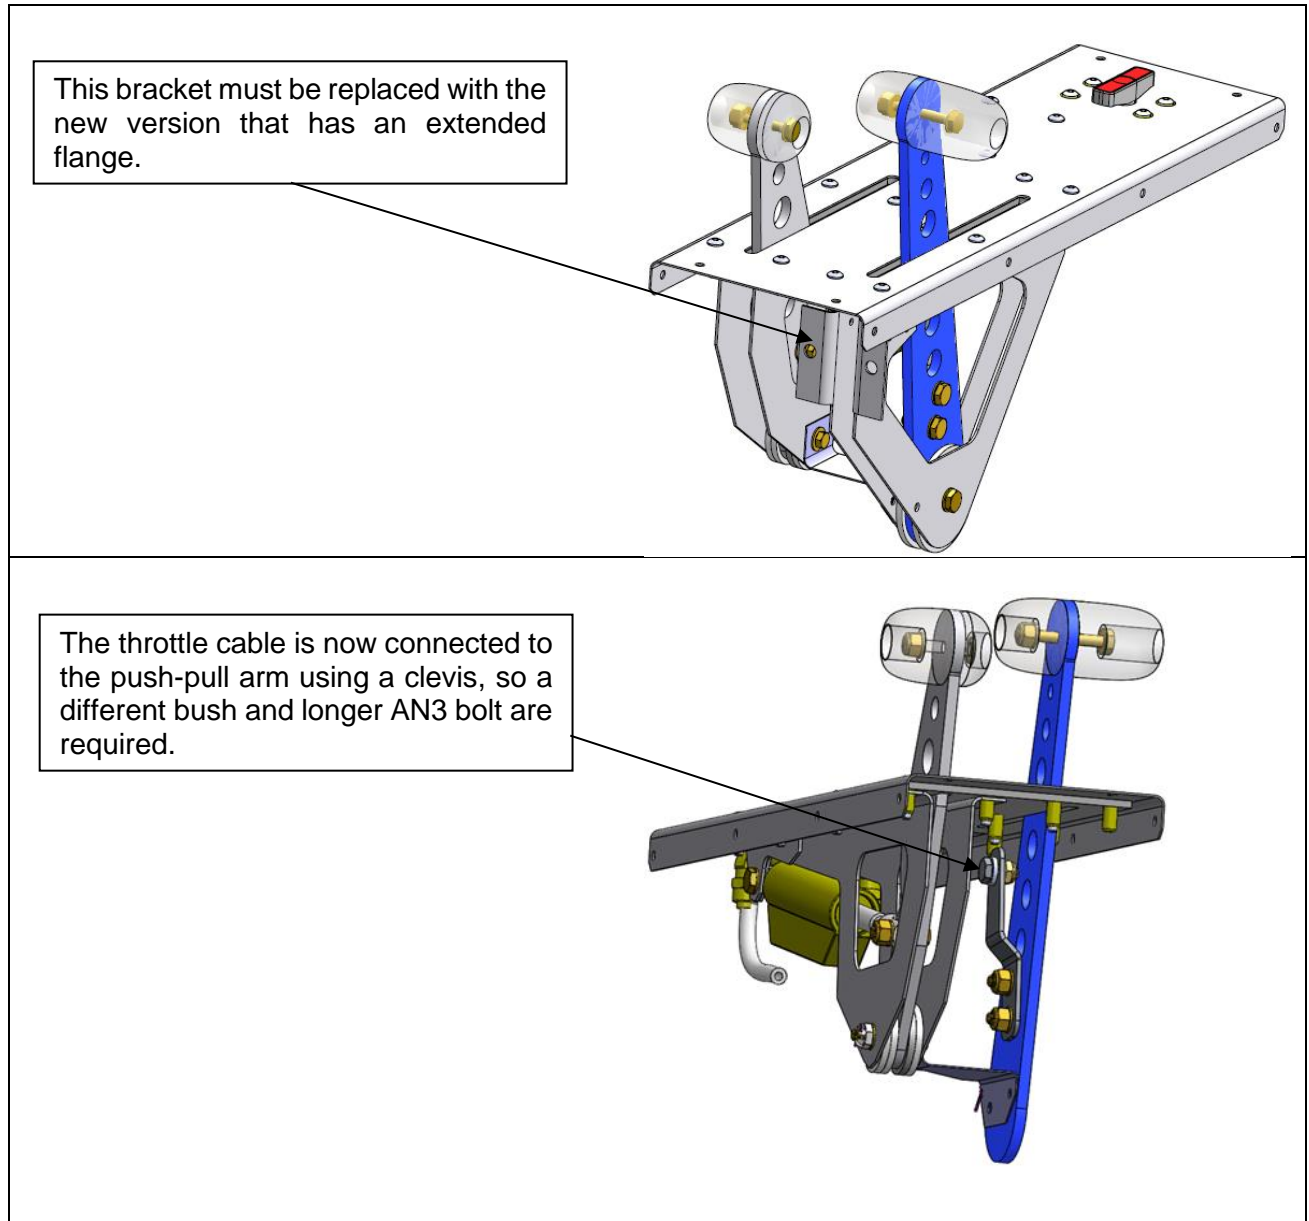
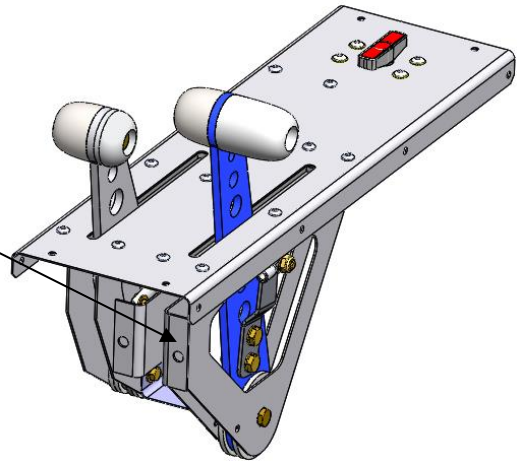
This bracket must be replaced with the new version that has an extended flange.

The throttle cable is now connected to the push-pull arm using a clevis, so a different bush and longer AN3 bolt are required.

The new throttle cable assembly makes use of a clevis and modified clevis sheath housing. Due to this, certain of the brackets in the throttle quadrant assembly need to be changed to the new versions. The figures below detail the required changes for the respective aircraft. Figure 1 details the components that need to change on Sling 2, Sling LSA and Sling 4 TSi, whereas Figure 2 details the changes for the Sling 4 High Wing.

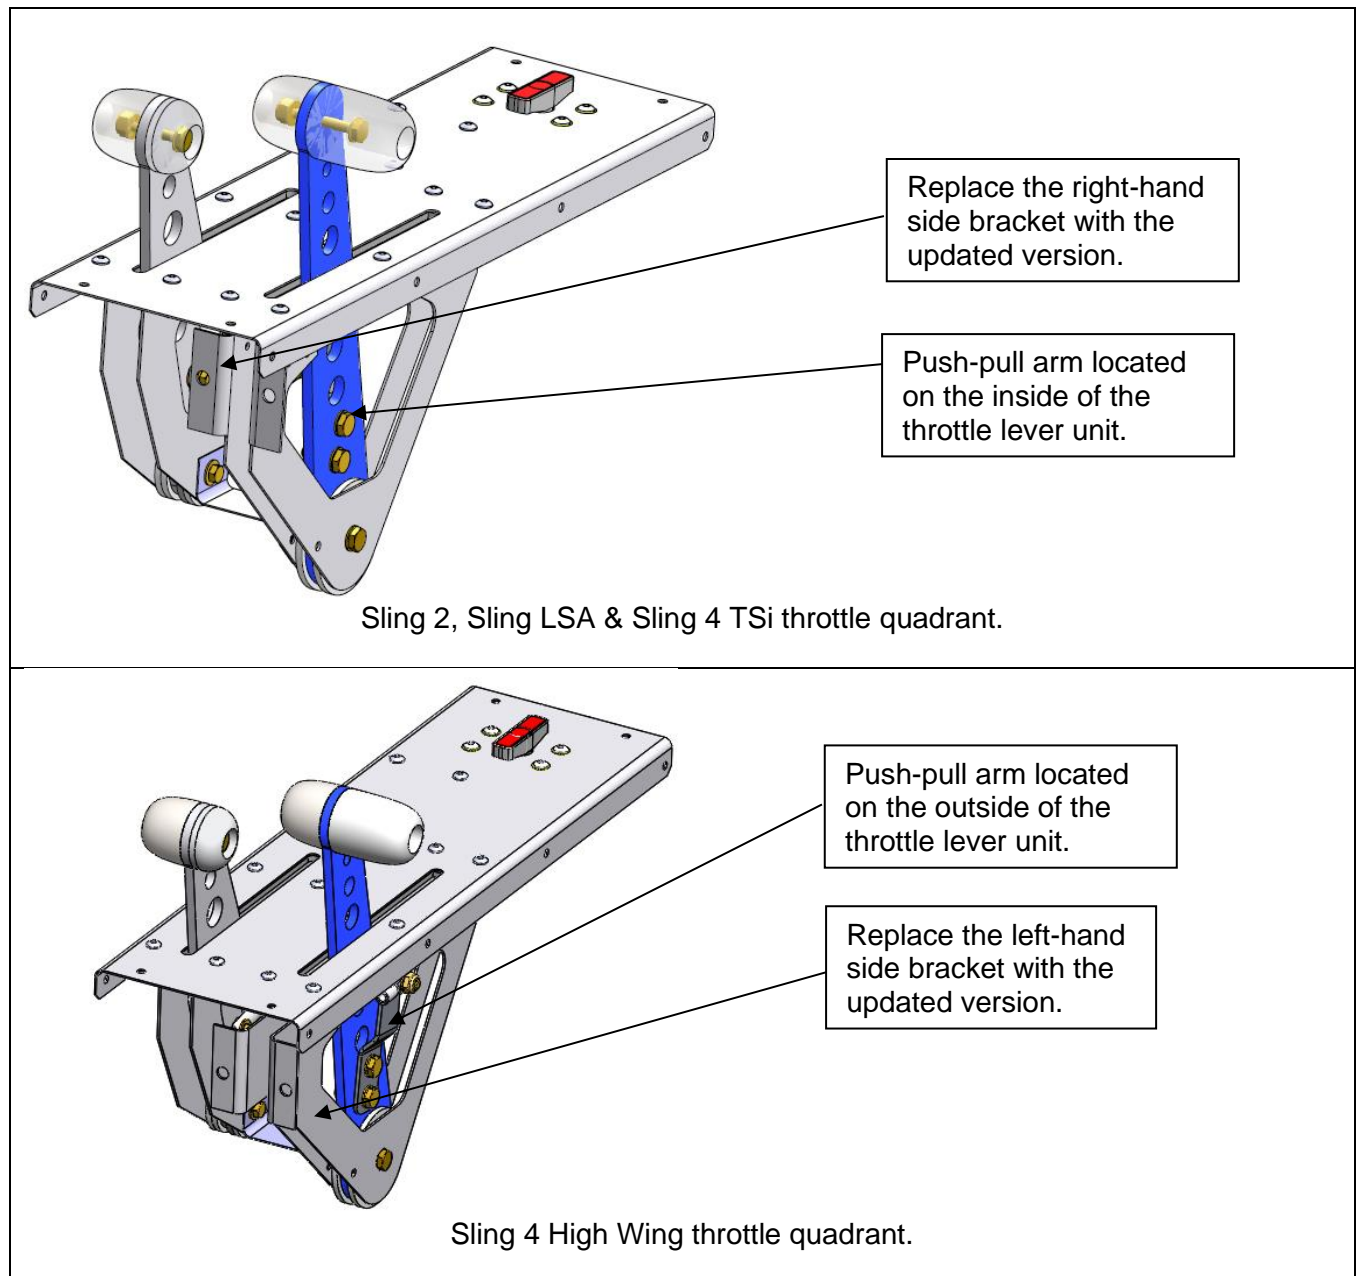
Figure 19

As depicted in Figure 19, the only difference between the throttle quadrant of the Sling 4 High Wing and the other aircraft is the side of the throttle lever that the push-pull arm is mounted to. The section below details the replacement of the throttle cable in order for the Sling 2, Sling LSA and Sling 4 TSi. In order to replace the components on the Sling 4 High Wing just mirror the process for the opposite bracket as depicted below in Figure 19.

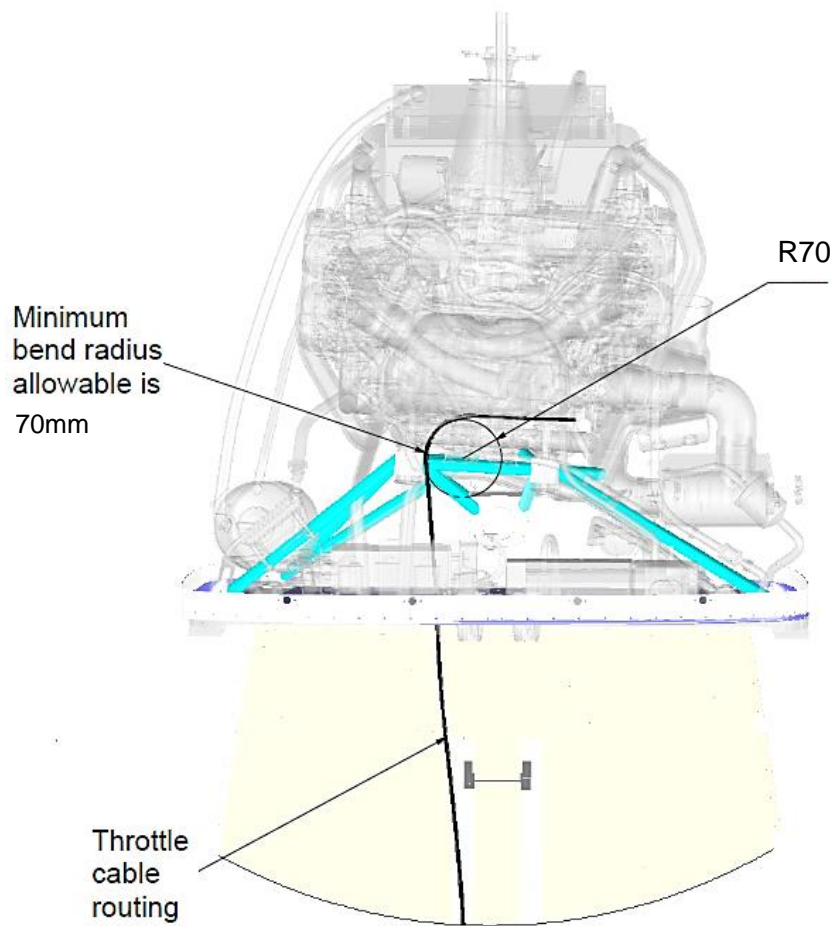
Figure 29

THROTTLE CABLE ROUTING

Step 10: Route the throttle cable and its sheath through the firewall, to the throttle lever on the Rotax throttle body. The cable should not have a bend radius smaller than 70 mm. If the bend is too tight there will be increased friction in the system. Ensure that there are no kinks in the cable from the throttle quadrant to the firewall. Standoffs may be used as necessary.
